# Home Inspection Report

<b>Inspection Property Address:</b>	2814 Amberleigh, Fayetteville, NC
<b>Client Name(s):</b>	Jill & Daniel Martin
<b>Date of Inspection:</b>	August 13, 2010
<b>Inspector's Name:</b>	Gerald W. Canipe
<b>Inspector's License #:</b>	0237
<b>Inspector's Signature:</b>	<i>Gerald W. Canipe</i>
<b>Associate Inspector's Name:</b>	N/A
<b>Associate's Inspector's License #:</b>	N/A
<b>Associate's Inspector's Signature #:</b>	N/A
<b>Real Estate Agent's Name:</b>	Ella Mandrin

# Home Inspection Summary Section

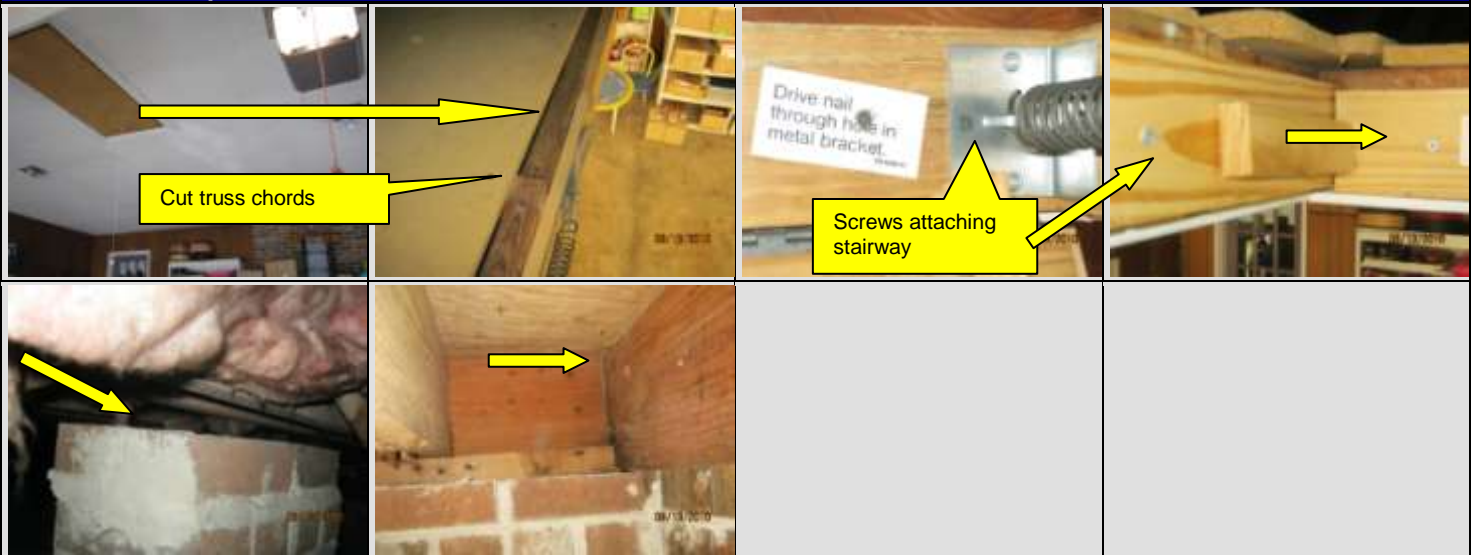
1. The bottom chords of several trusses have been cut in the attic over the garage to accommodate the pull down stairway access. Trusses should not be cut as it affects the structural integrity of the roofing system. Recommend further investigation by a truss designer or NC Licensed Structural Engineer to specify the repair and repair as required by a NC Licensed General Contractor or truss manufacturer. Recommend a copy of the repair specifications/certification by the truss designer or structural engineer be provided to the buyer for future reference as will likely be needed.

Additionally, the pulldown stairway has been installed using screws instead of nails. Screws are not rated for shear strength and are susceptible to failure. The manufacturer instructions on the stairway also states to "drive nail through hole in metal bracket" however a wood screw was used. This poses a structural and safety hazard.

2. Three support piers under the front portion near the hall bath are not in contact with the joists above and therefore are not providing the intended support. One pier also noted toward the rear of the home also not in contact with the joists. This can lead to settlement over time resulting in unlevel floors, etc.

3. Suspected evidence of wood destroying insect activity observed at the floor system exterior band in the corner of the home adjacent the crawl space access door. Recommend further investigation by a NC Licensed Pest Control Operator and a NC Licensed General Contractor to determine if repairs are required.

4. Recommend further investigation of the area under the rear exit door from the kitchen nook area, joists/band/ledger strip, and subflooring and repair as required by a NC Licensed General Contractor.

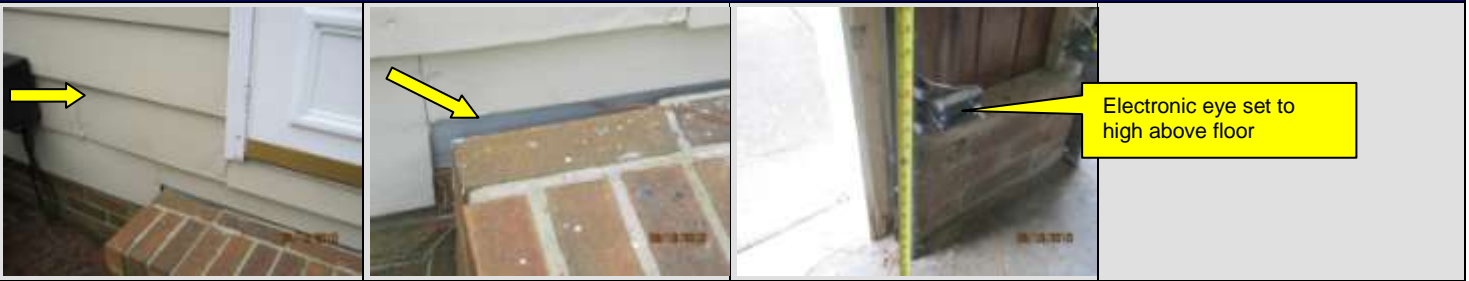
1. Damaged siding noted left of the rear door. Damage will likely continue and can lead to additional damage if not repaired.

2. No flashing noted behind the rear steps and the exterior band is visible. Water can enter between the steps and the wet the exterior band in this area. Flashing should be behind the siding and the steps to prevent water damage to the exterior band.

3. The electronic beams of the garage doors safety reversing feature are mounted approximately 15 inches above finished floor level. Garage door manufacturers installation instructions typically require the sensors be placed no more than 6 inches above finish floor level. The resistance reversing feature did not reverse the doors when the doors encountered reasonable resistance. This is considered a safety hazard.

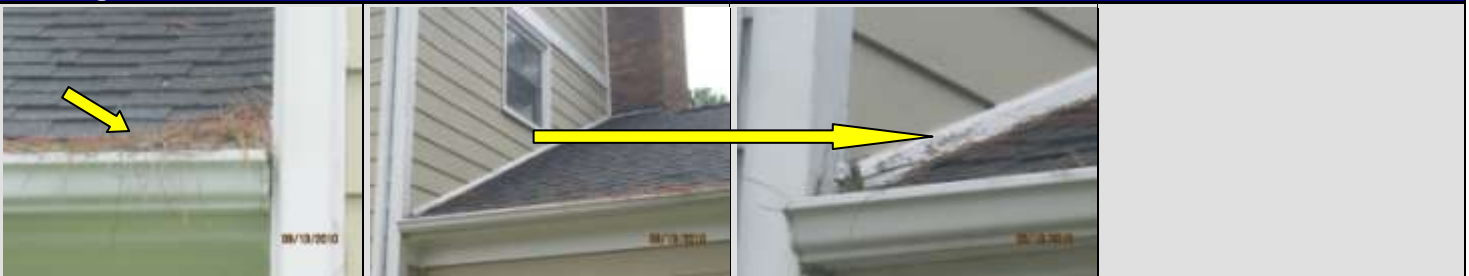
1. The gutters are full of straw preventing proper drainage. This can lead to overflow and damage to the fascia boards behind the gutters.
2. Wood molding has been used over the garage roof where it meets the siding of the main structure. The wood molding appears in contact with the shingles and against the lap siding. This is not a typical construction detail. Typically, the siding should stop short of the shingles approximately 1/2 inch and the flashing is visible between the siding and the roof. Wood in direct with the shingles is susceptible to rot/decay. Recommend further investigation to ensure this area is properly flashed and repair as may be required.

3. Standing water noted on the ground in the crawl space under the air conditioning coils due to no condensate drainage. The crawl space was damp at other areas sporadically. Elevated moisture in the crawl space is an undesirable condition that can lead to mold growth, decay, etc. Recommend the installation of the vapor retarder to cover the ground and prevent moisture migration from the ground to the wood framing members.

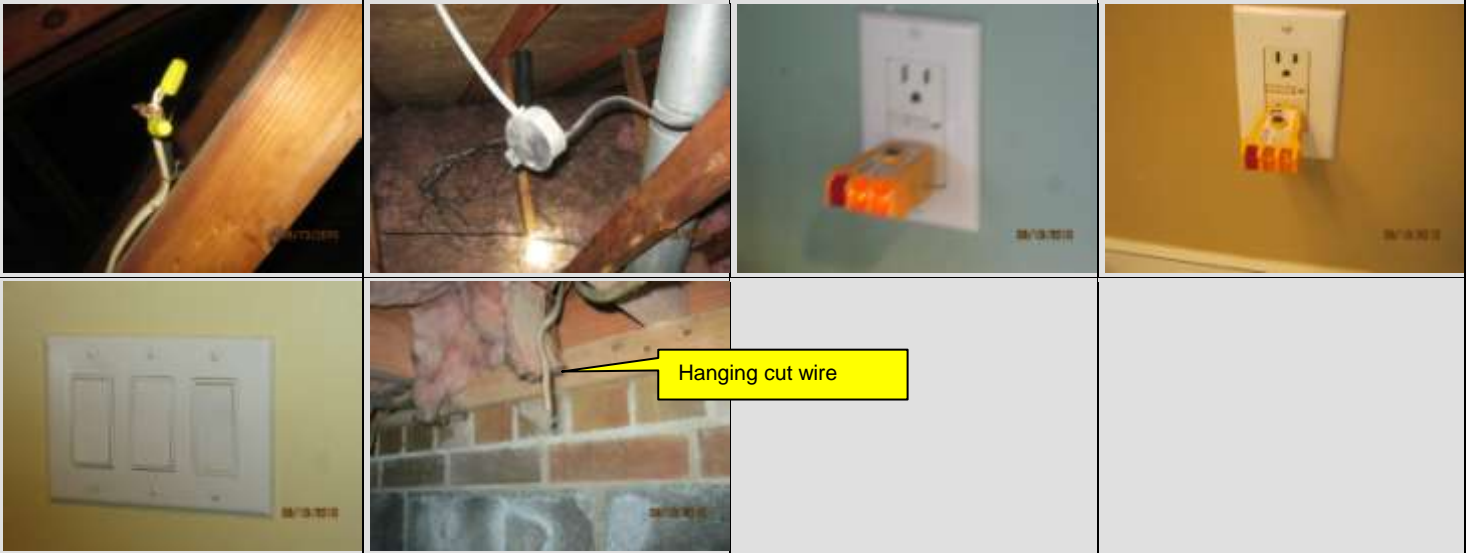
1. Exposed splice noted in the attic over the garage access stairs.
2. The junction box for the attic vent fan is not mounted in the attic and is hanging unsupported.
3. Ground fault outlets in the kitchen and the master bath did not shut the power off when a ground fault was simulated or the test button operated.
4. Unable to determine what two of the three switches operates at the top of the stair landing. The seller may be able to provide further insight. Further investigation by a NC Licensed Electrical Contractor may be desired.
5. A cut wire was noted in the crawl space along the front foundation wall. It is not known what this served or if it has been properly de-energized. Recommend further investigation by a NC Licensed Electrical Contractor.
6. Open junction box observed in the crawl space under the hall bath area with no cover plate poses a safety hazard.

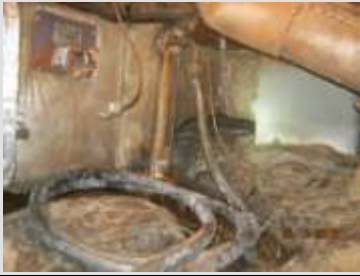
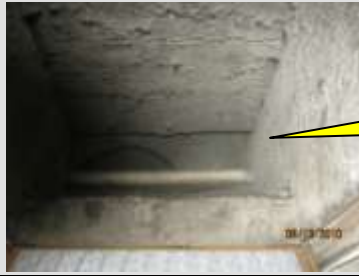
Dust buildup inside return air

Considerable rust and corrosion was observed of the air conditioning evaporator coils in the crawl space. Standing water was noted on the ground under the unit due to no or improper drainage of the condensate and likely failure of the condensate drainage due to rust/corrosion. A temperature drop across the coils was measured at 12 degrees and a range of 15-22 should be expected indicating inadequate cooling. Considerable dust was noted inside the return grill downstairs suggesting the coils of the air handler are likely partially clogged. The ducts are the original and the insulation is coming loose in several areas allowing heat loss/gain. The system is aged beyond it's normal life expectancy and based on the current condition replacement is recommended. Near term failure can be expected.

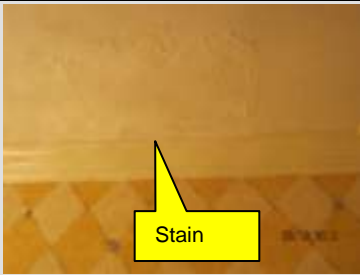
Stain

1. Evidence of repair to the ceiling in the downstairs hall bath just over the entry. A stain has occurred since the repair indicating leakage is still occurring. The area was checked with an electronic moisture and tested positive for high moisture. This is directly under the upstairs bathtub. Recommend further investigation/repair as required.
2. Delamination of the paneling observed in the garage along the front wall nearest the street. Recommend further investigation to determine if any hidden damage may be present inside the wall cavity.

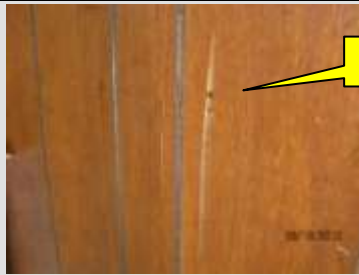
Delaminated siding

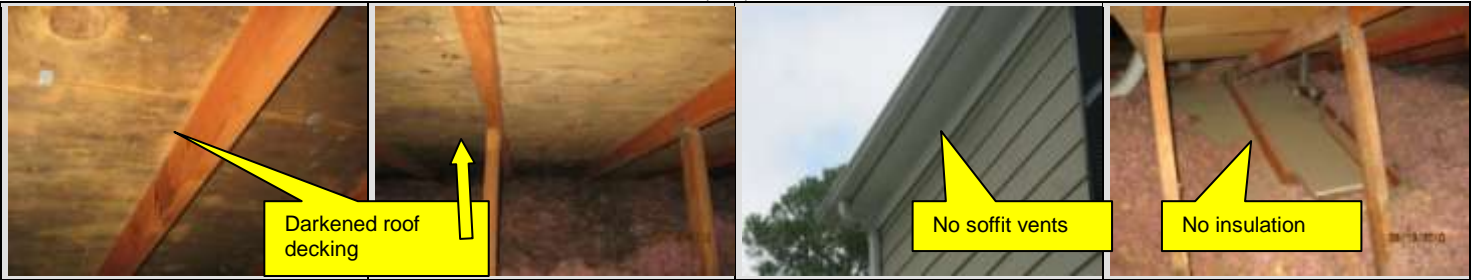
1. Mold/staining noted on the underside of the roof decking in the rear right corner and one small area in the approximate middle near the edge of the rear roof. This is typically due to inadequate ventilation and is allowing condensation to occur on the underside of the roof decking in this area. This can lead to additional damage over time if not corrected. The roof covering appears to have recently been replaced and a ridge vent added for ventilation. However, there are no vents under the soffit to allow for proper ventilation to occur. Also ensure bathroom vent fans are exhausted to the daylight and not the attic. Recommend soffit vents be added and ensure they are not blocked by insulation when installed. Subsequent monitoring is also recommended to ensure measures taken are effective.

2. Unable to obtain power for the attic ventilation fan. The switches at the top of the stair landing were operated to no avail. It is not recommended the ventilation fan be used since a ridge vent has been installed on the roof. Using the ventilation fan will likely interrupt the air flow and simply draw air from the ridge vent as the path of least resistance thereby not providing cross ventilation to all areas.

3. Area of missing insulation noted over the upstairs hall bath and under the downstairs half-bath is allowing heat loss/gain.
